Replace the Entire Control Arm Assembly Fix the Cause Not Just the Symptom

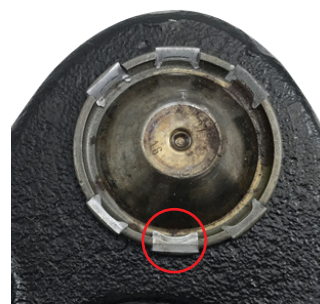
Figure 1

OEM arm with ball joint pre-press out

- Stand-alone aftermarket ball joints are available for these applications (K6541 and FPD no. DM15.46541), however the OEM control arm is not specifically designed to easily receive a replacement ball joint (**Figure 1**)

- Before pressing out the OEM ball joint, the metal locking tabs must be bent or chiseled away to allow for a proper press out (**Figure 1**). (If you press out the OEM ball joint without removing the tabs you will ruin the control arm.) When removing these tabs, you risk damaging the ball joint seat, which can lead to its replacement “swimming” ultimately resulting in premature ball joint failure. Even if you successfully remove the tabs and press out the ball joint a misaligned press, or any burrs/hard edges (**Figure 2**) left over from removing the tabs can further damage the ball joint seat (**Figure 3**) making the install of any replacement dangerous and negligent.

The O.E.Brand by FPD solution to the above problem is our part no. CL20869200*. The advantages of using our complete control arm assembly over simply replacing the ball joint:

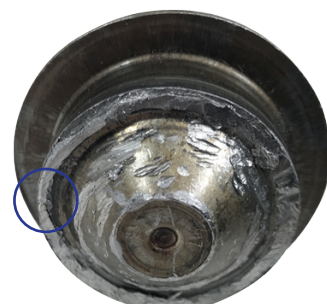
Figure 2

OEM ball joint

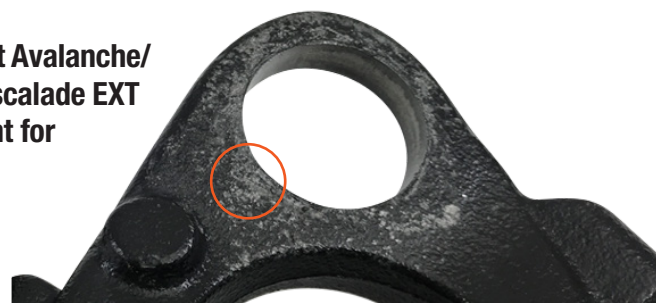
Figure 3

OEM arm post-press out
